U. S. NAVAL CIVIL ENGINEERING LABORATORY
Port Hueneme, California

Technical Note N-360

CORROSION STUDIES ASSOCIATED WITH AN AIR
BLAST CLOSURE UNIT

30 July 1959

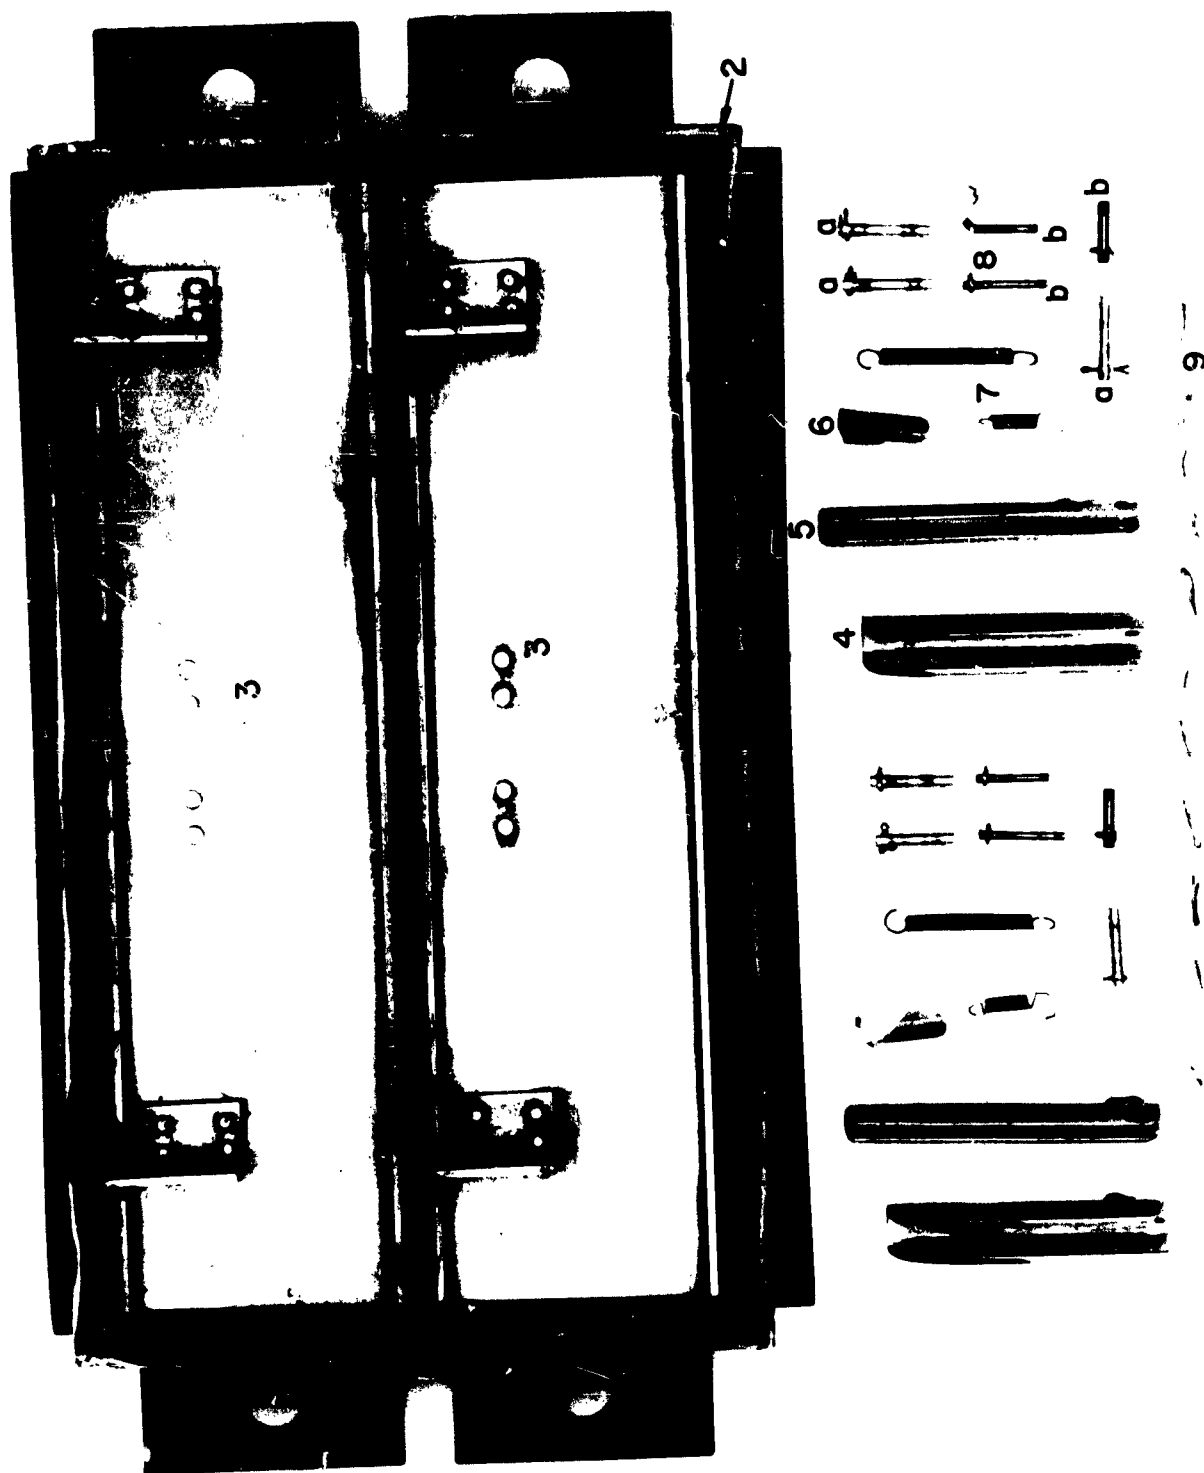
Figures 1 and 2 view the closure assembly from the inside. Figure 1 shows the doors closed and Figure 2 shows the doors open.

Figure 1. Moving parts of Closure Unit before exposure, View 1.

1. Use neoprene foam rubber for the gasketing material (2), Figures 1, 2, and 3.
2. Fabricate the louver frame, (1) Figures 1, 2, and 3, and brackets (11a, 11b) Figures 3 and 21, from 6061 aluminum alloy.
3. All supporting pins (8) and cotter pins (9), Figures 16, 17 and 18, should be heavily cadmium plated (0.001 inch) and grease coated with an inhibited soft grease such as AN-C-124a, AM3 Type II.
4. All metal springs should be coated with an inhibited soft grease such as AN-C-124a, AM3 Type II.

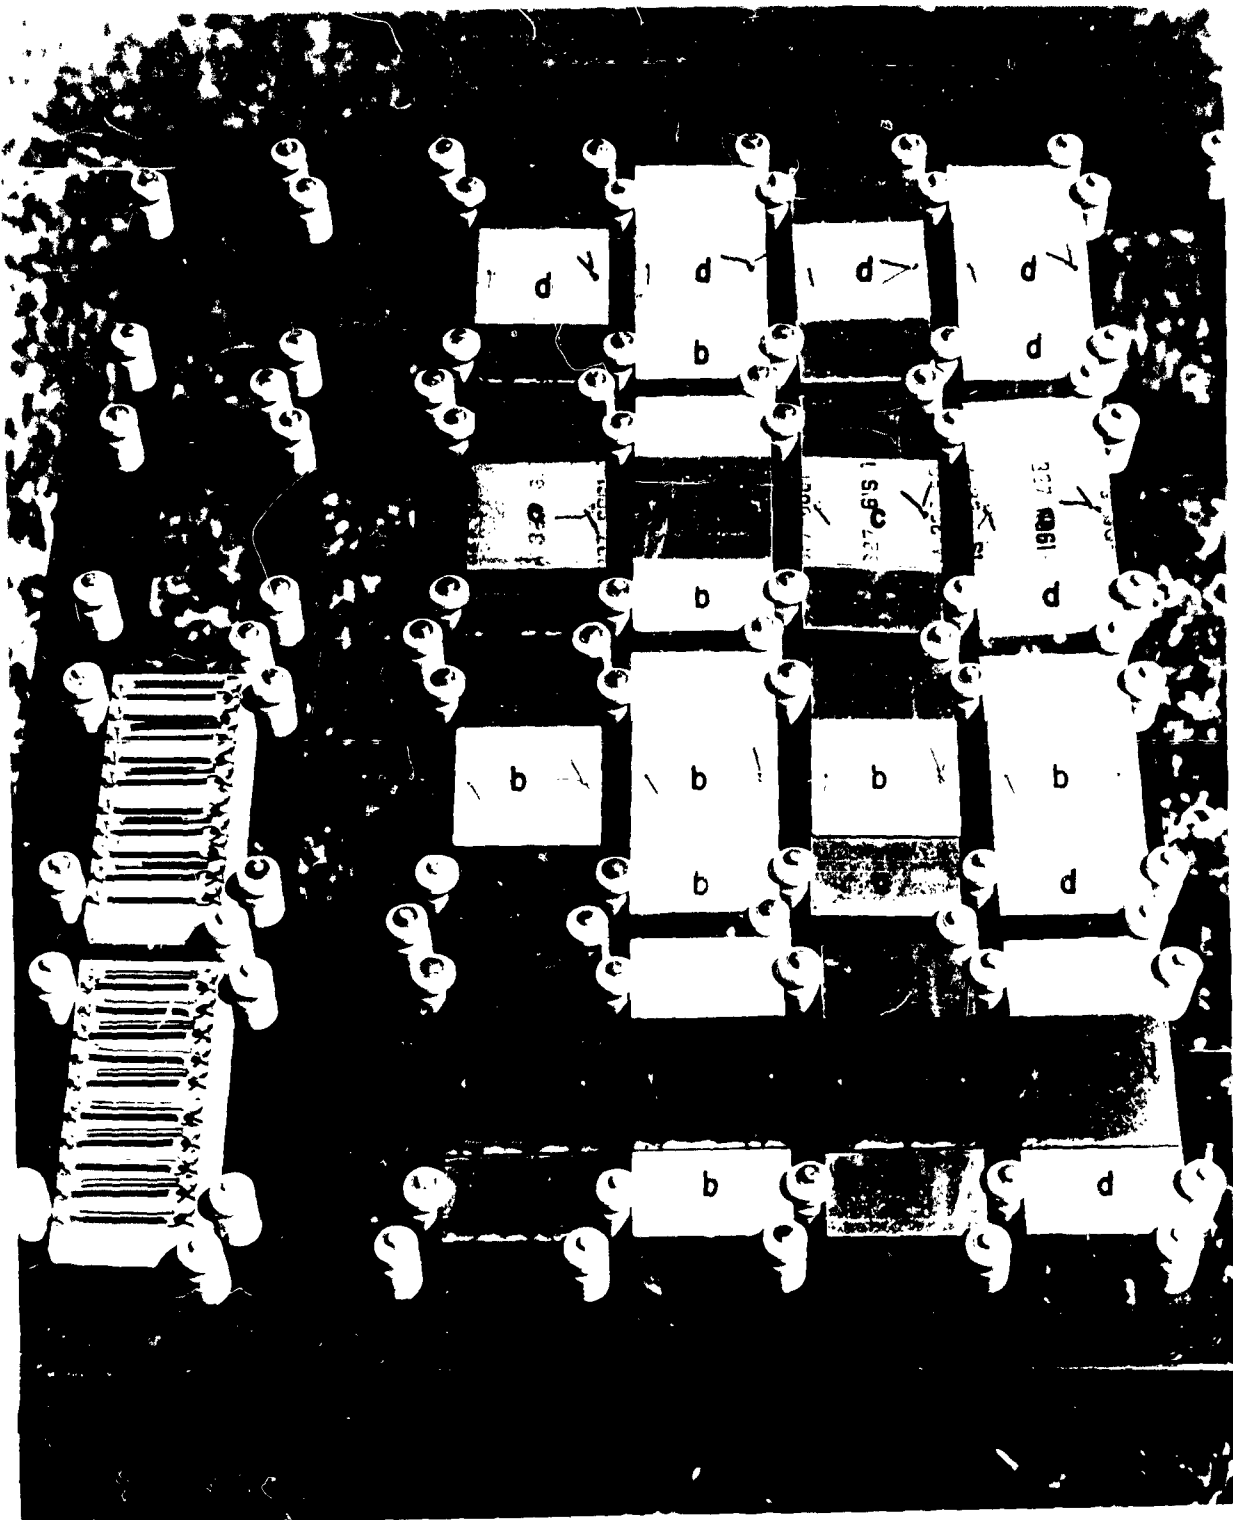
Figure 7. Test panels on exposure rack. a- Mild steel; b- 6061 Al; c- Cd plate; d- 2024 Al.

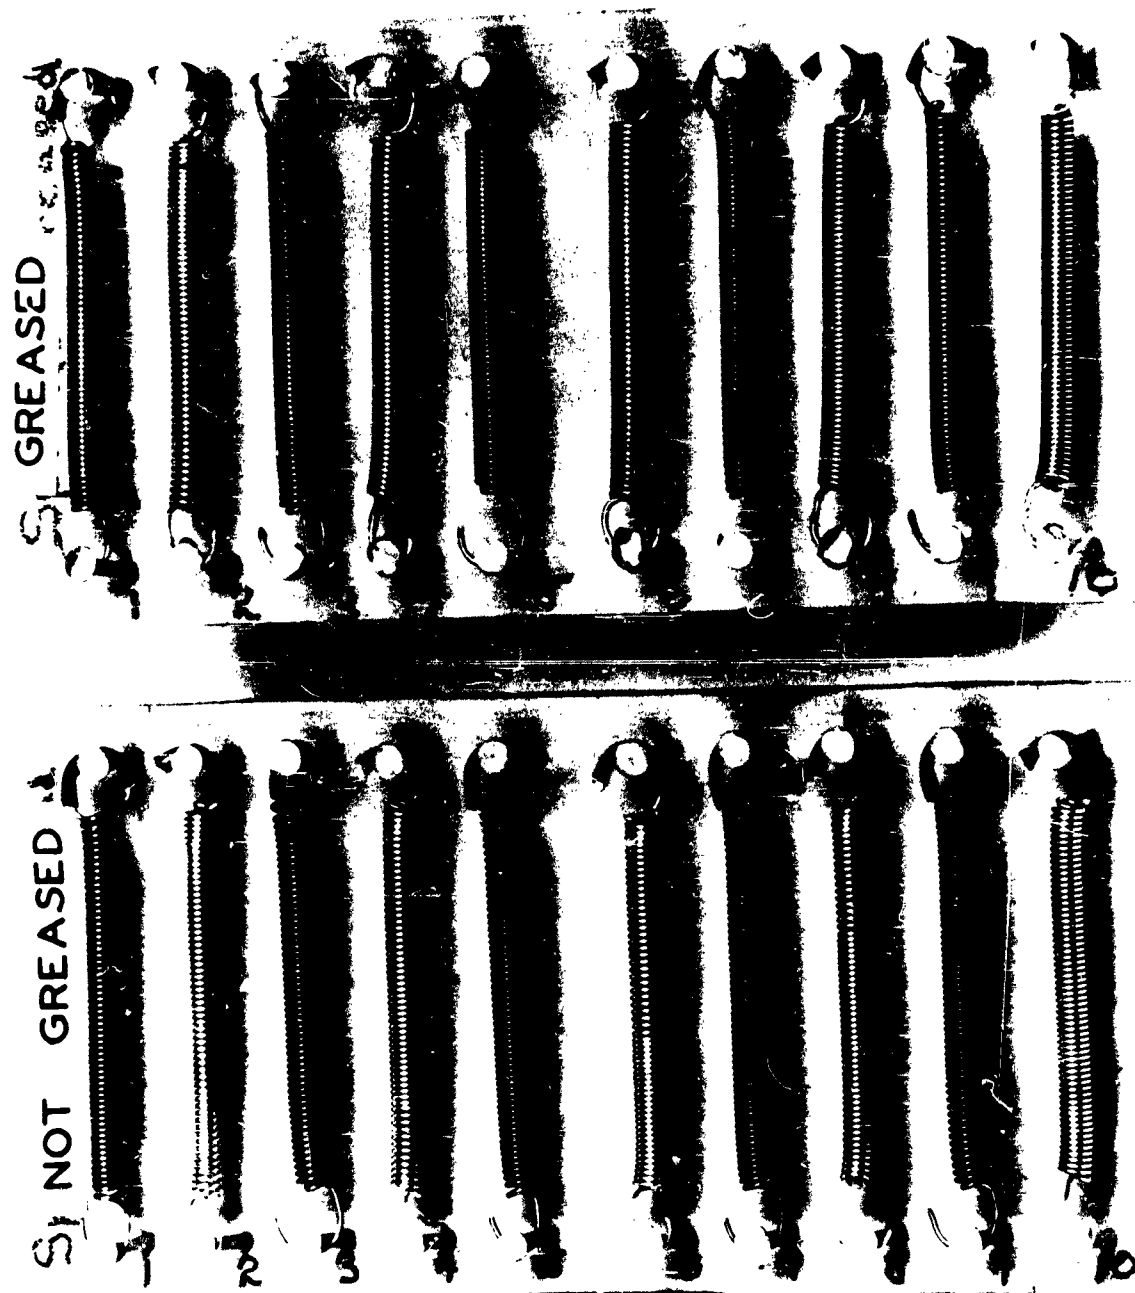
Test springs were formed from 0.033 inch piano wire and closely resembled the large spring in the closure unit in size and length. Forty springs were prepared and twenty of these were cadmium plated. A soft film inhibited grease (AN-C-124a - AM3 Type II) coating was applied to ten of the plated and ten of the unplated springs. The springs were then placed in specimen holders in such a way that five plated and five unplated test springs were in each of four specimen holders. One sheltered (Figure 9) specimen holder contained grease coated springs and one (Figure 10) contained ungreased springs. Greased and ungreased springs were also placed on unsheltered specimen holders. (Figure 11)

Figure 11. Test springs in unsheltered specimen holders, before exposure.
